HI-CUBE PALLETS VERSUS STANDARD PALLETS

DAMAGE PREVENTION

360 QUALITY DAMAGE CARGO SURVEYS

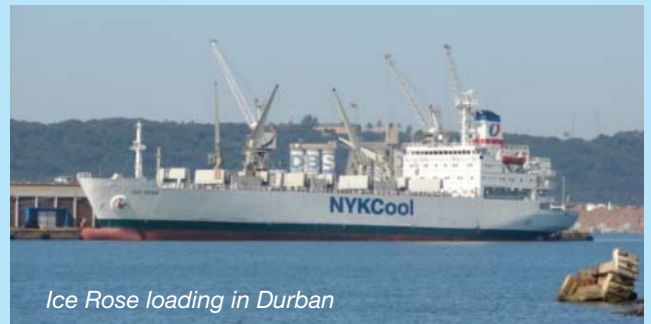
The cargo was being loaded on the specialized reefer vessel, Ice Rose, destined for Japan.

Ice Rose loading in Durban

closed and cooling started in order to protect the cargo and to ensure not to exceed the protocol," he added. "The ship was able to bring all pulp sensors below 0.0 celsius in a very short time - the fastest any vessel has taken to stabilize since the start of citrus exports to Japan."

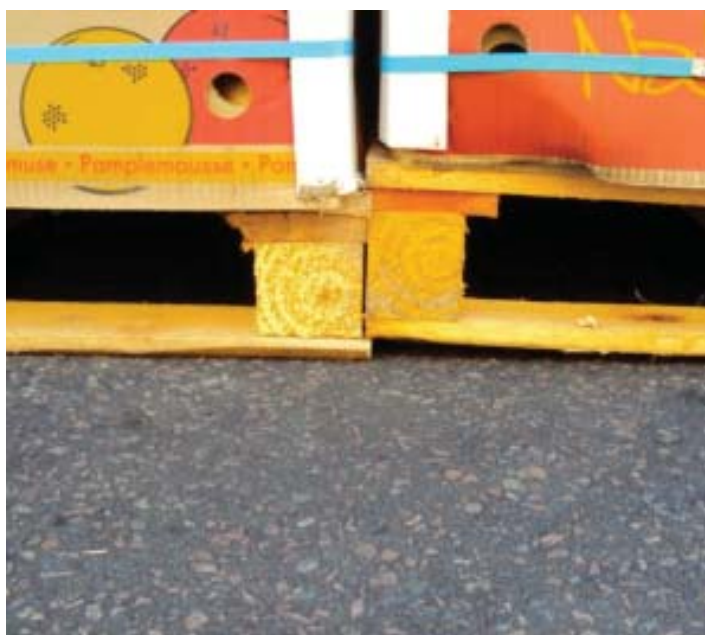
Creating damage on the quay

- 1** *Pallets should be lifted more during transport in the warehouse to avoid that pallets bases are touching the ground.*
- 2** *Keep a distance on the quay side between pallets before loading into the pallet cage.*
- 3** *Inspection and repairing pallet on the quay side by FPT personnel.*
- 4** *Inspection cargo by an independent inspection body in the cargo holds.*
- 5** *Prepare 24 per-slung pallets to create more space in discharge port when pallet cage is used.*

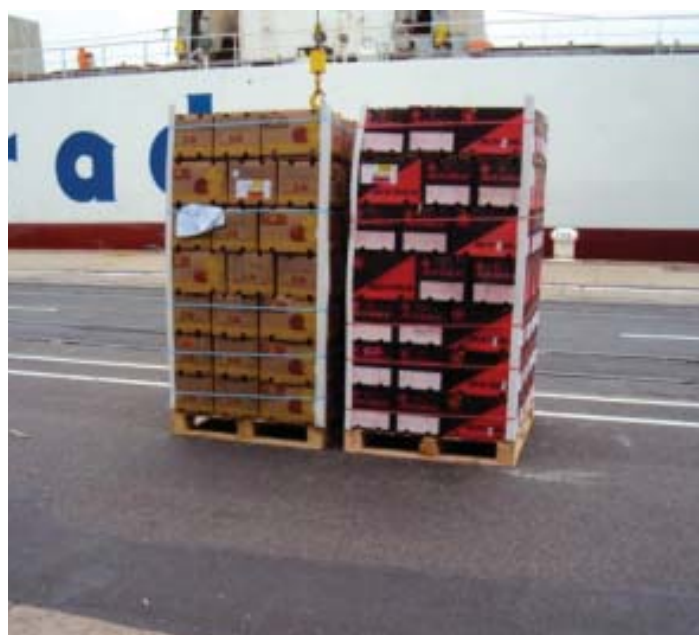
Avoiding damage on the quay side

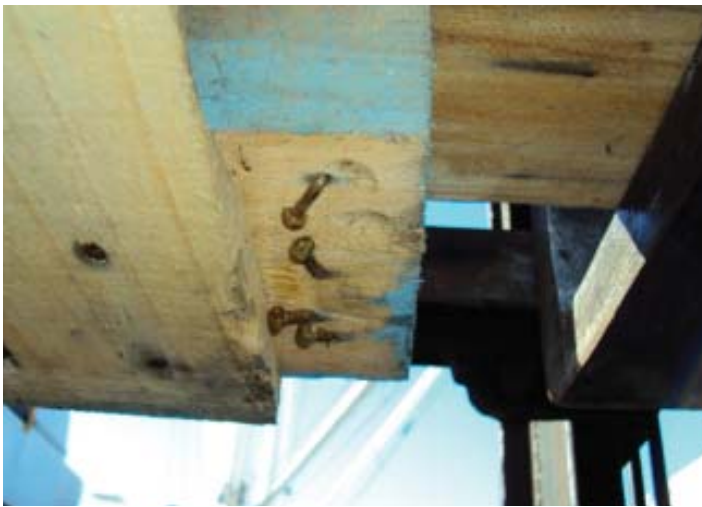
In Cape Town the situation is different. The cargo arrives in a much better condition. Because the cargo was meant for a USDA voyage, it is received and pre-stowed for a certain time in reefer chambers at the terminal. On the quay side it was seen that still some repair on pallet bases was necessary. After investigation it appeared that flat rusty nails were present between the blocks and

the slats of the pallet base. These flat nails affect the assembling strength of the pallet and this was a complaint received from the discharge port Philadelphia. To avoid damages in the discharge ports, 'chep' pallets were used in the pre-sliling in the hatch squares. When this was discussed with the management of the Terminal it was agreed that:

Flat rusty nails

- 1** *pallets will be inspected before stowage in the reefer chambers.*
- 2** *"Chep" pallets will be only used for the pre-slung pallets*
- 3** *Terminal-in inspection will be intensified on pallet base damages and focusing on flat nails between blocks and slats*

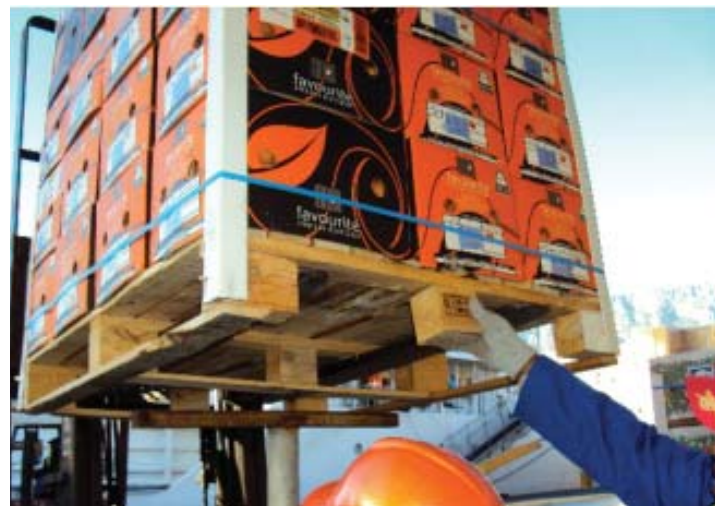
Repair of pallet base

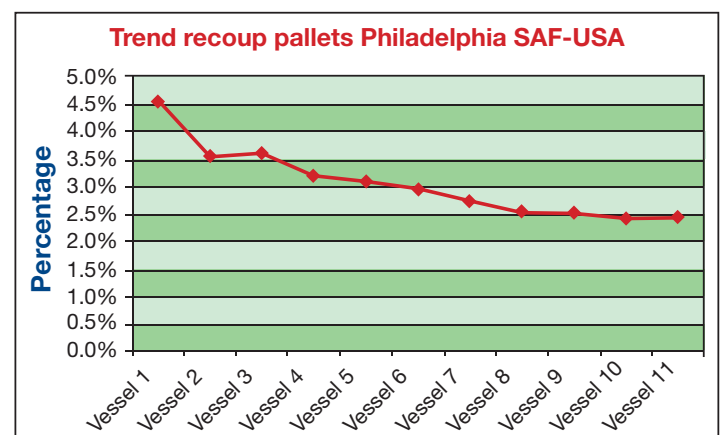
For Cape Town this resulted in a decrease of recoup pallets in the discharge port from 4.5% to 2.5%:

From the graph right, it can be seen that by cooperation between load port, discharge port and shipping line, cargo damages can be influenced.

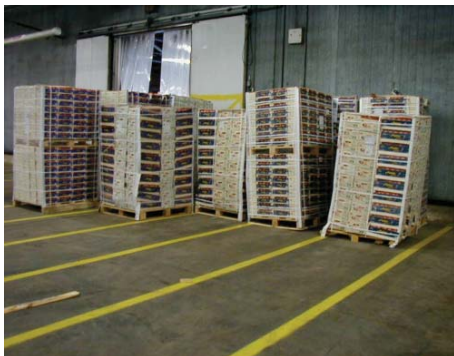
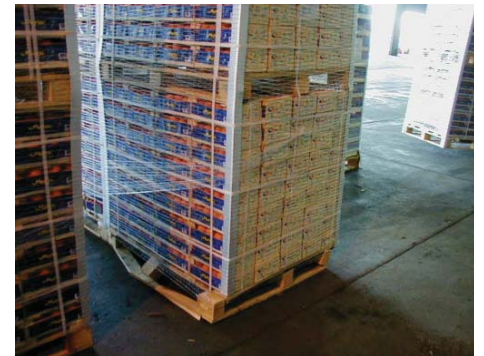
The writer has been actively involved as a marine surveyor with the Moroccan Clementine trades since 2005. Before 2007 the typical base skid of the palletized cases was of the block type that became easily damaged in stow as well as during normal handling. This resulted in unstable pallets that often collapsed with loss of produce. These damaged pallets had to be restacked to be made fit for further transportation for

The photographs below illustrate the conditions of block and standard pallets

Block type base skids

In 2007 with the initiative of SRC and the cooperation of the Moroccan shippers and packing houses the block type base skids were phased out and replaced with standard type pallets.

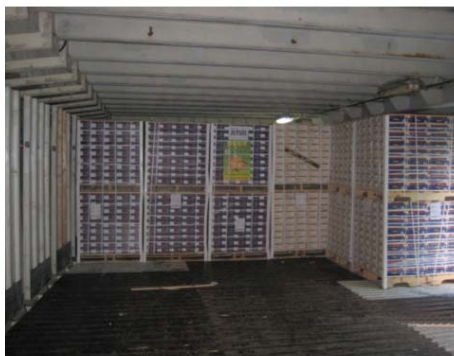
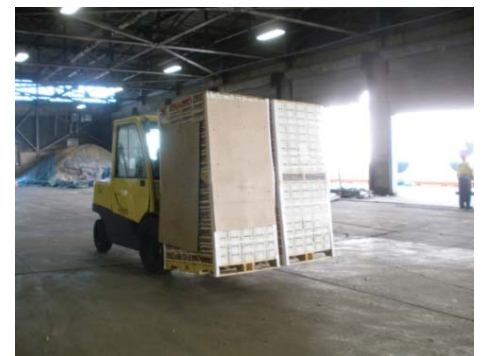
The damages to the base skids, either in stow or due to handling were dramatically reduced from about 50 pallets on average to about 8 and less.

Standard type base skids
